Arboricultural Note

Project: Bengo Nursery (ARB9392)

Preliminary Arboricultural Appraisal

December 2016

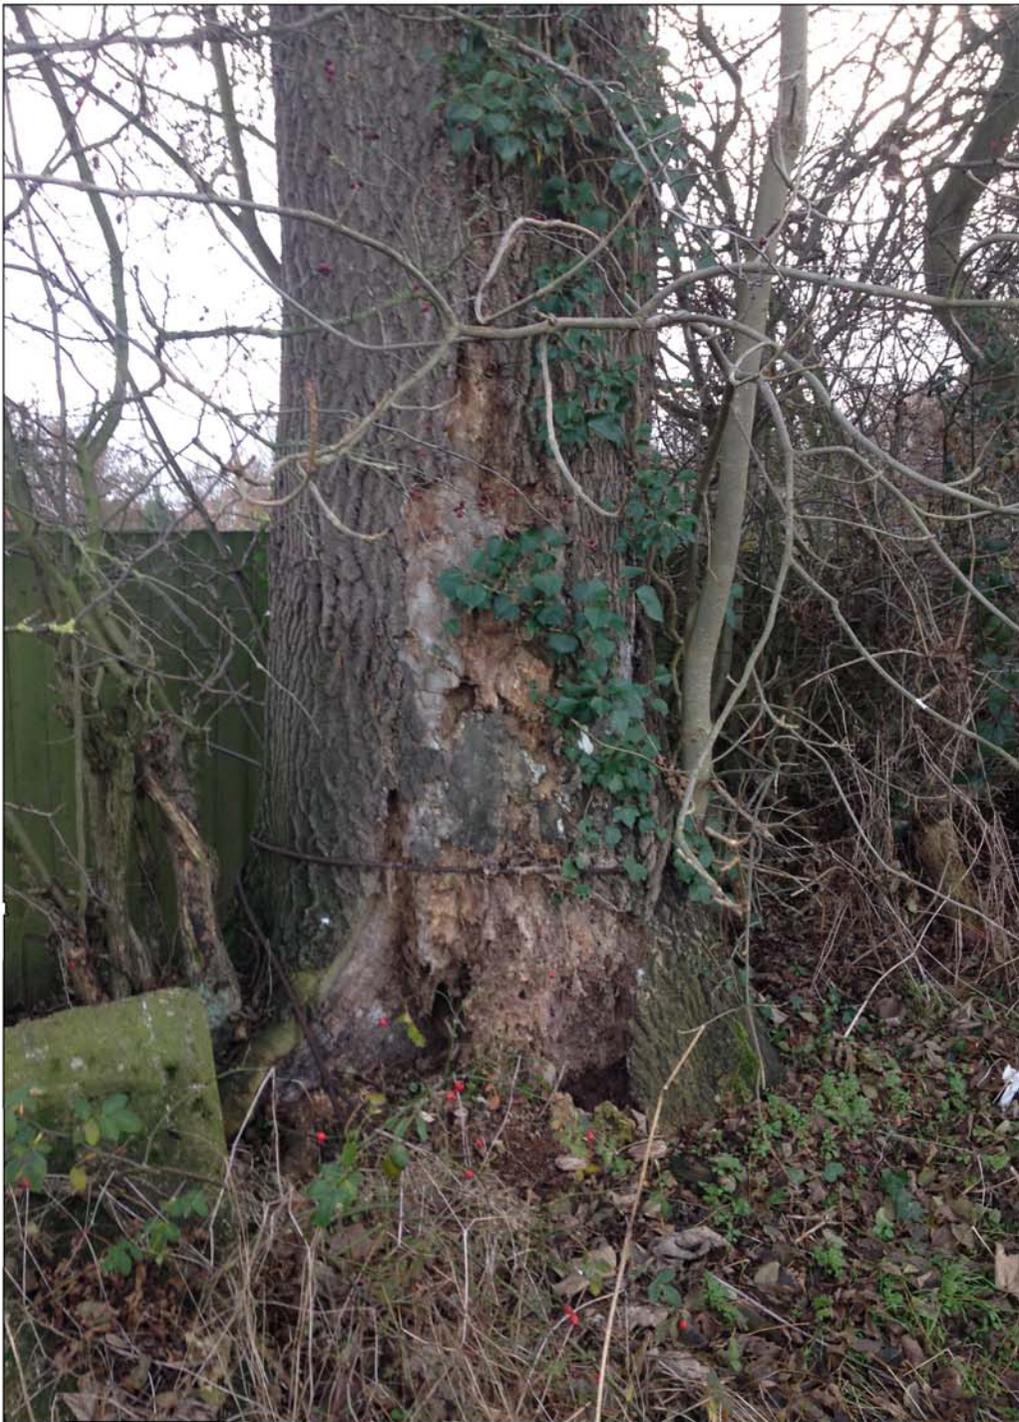
- 3.10. Category U tree cover: Three offsite trees positioned on the site's northern boundary are considered unsuitable for retention regardless of promoting the site for development. T2 Ash and T3 Sycamore, both feature a significant amount of decay within large basal cavities. As such, their early loss is anticipated through structural failure. T4 Lime, has significant dieback within the upper canopy and is considered to be in a state of terminal decline.

T2 (Ash) - Category U - Located on northern boundary

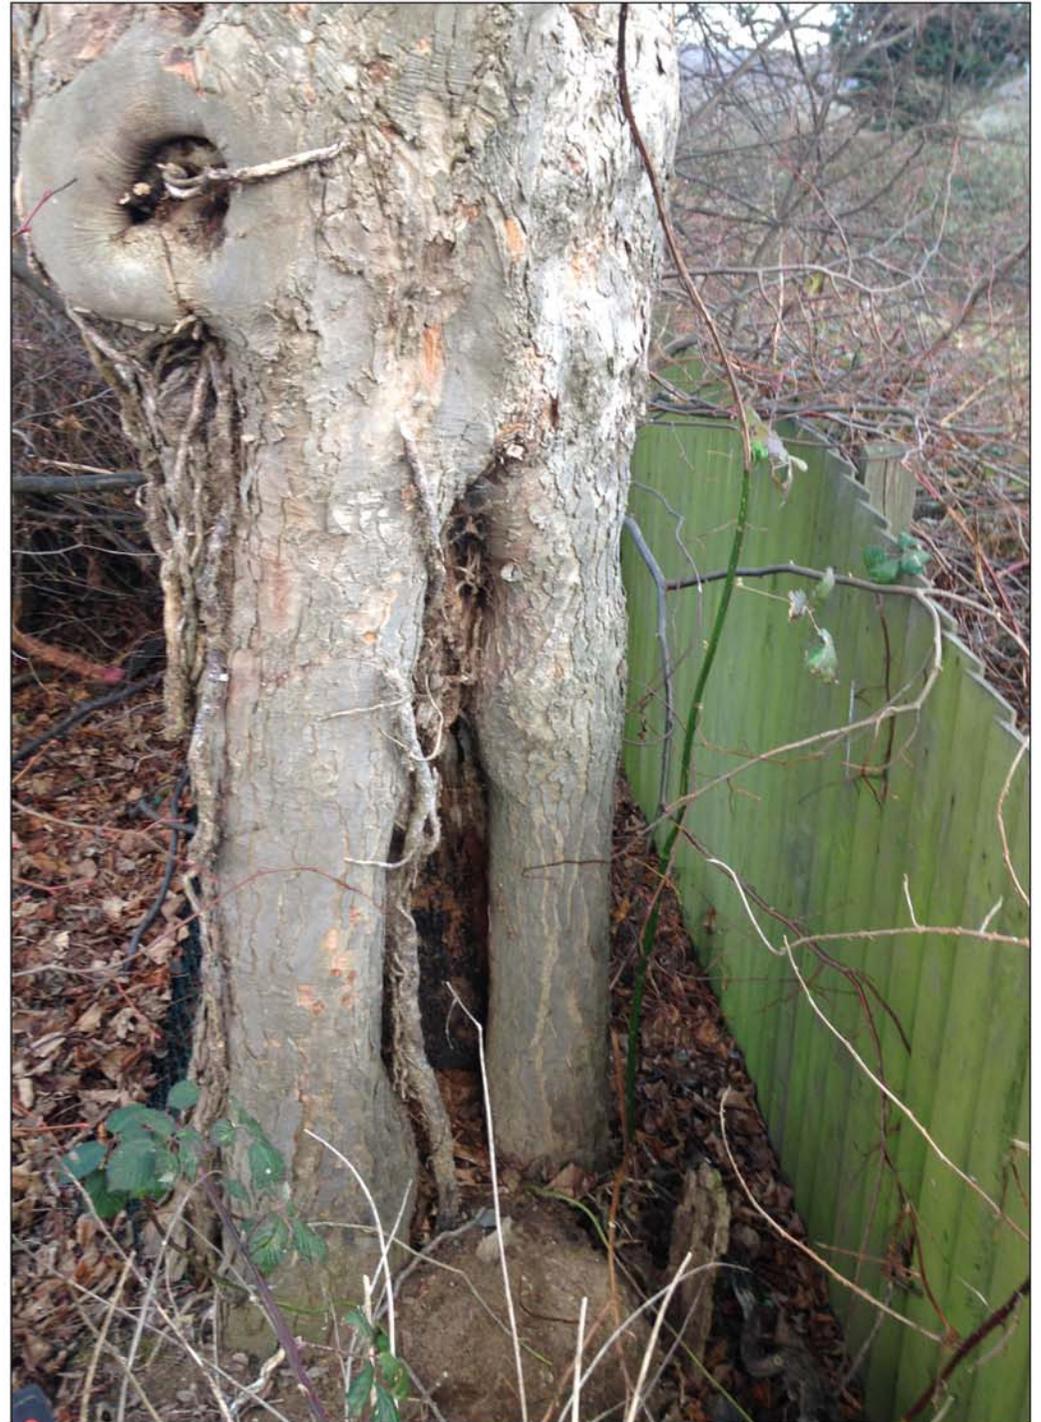
T3 (Sycamore) - Category U - Located on northern boundary

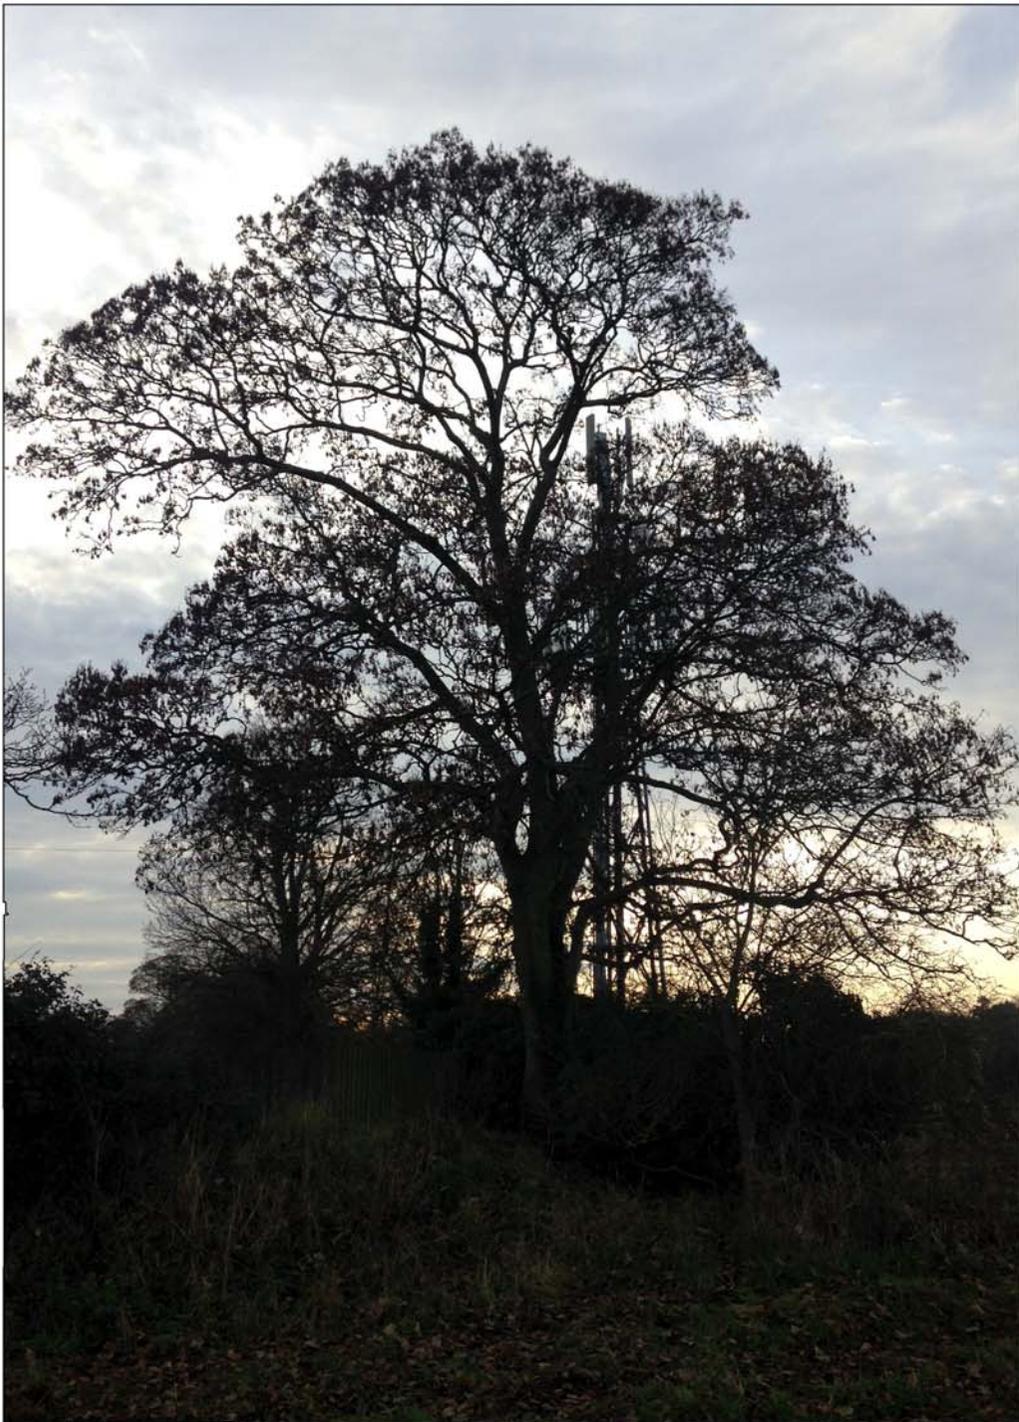
- 3.8. T1, T5 Sycamore and T6 English Oak, are worthy of individual distinction, located offsite and are considered to be moderate quality components of the site's boundary tree cover. Displaying partially impaired, structural or physiological condition (which deterred their consideration for a higher category) they each provide structure to the boundaries and offer important contributions to the site's amenity.

T5 (Sycamore) - Category B - Located on northern boundary

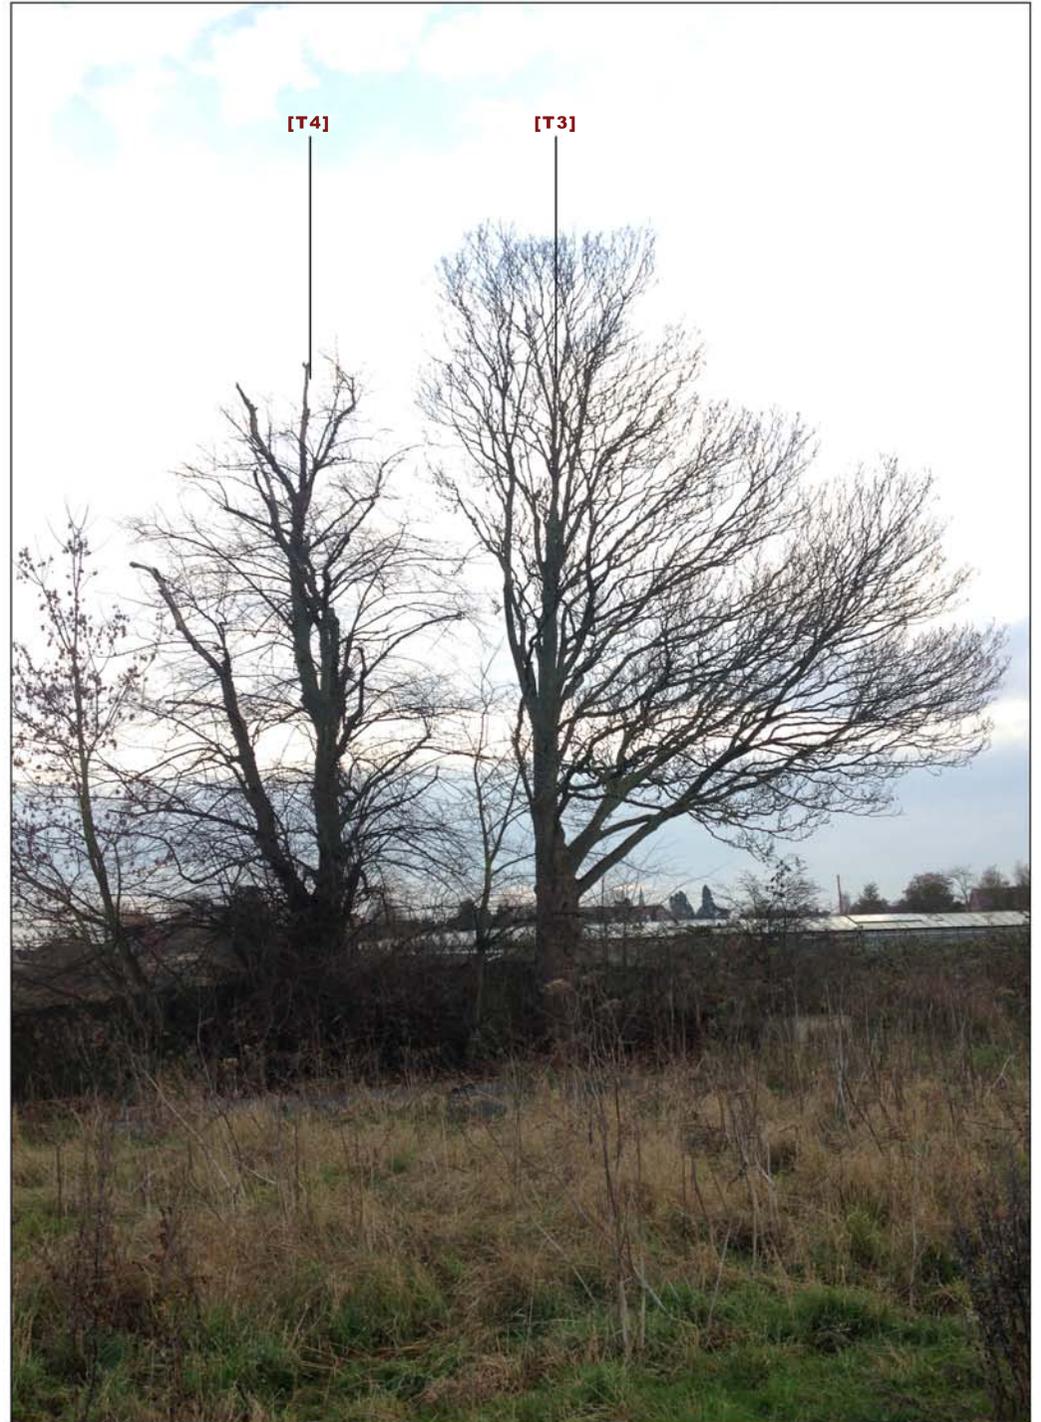
T4 (Common Lime) - Category U, T3 (Sycamore) Category U - Located on northern boundary

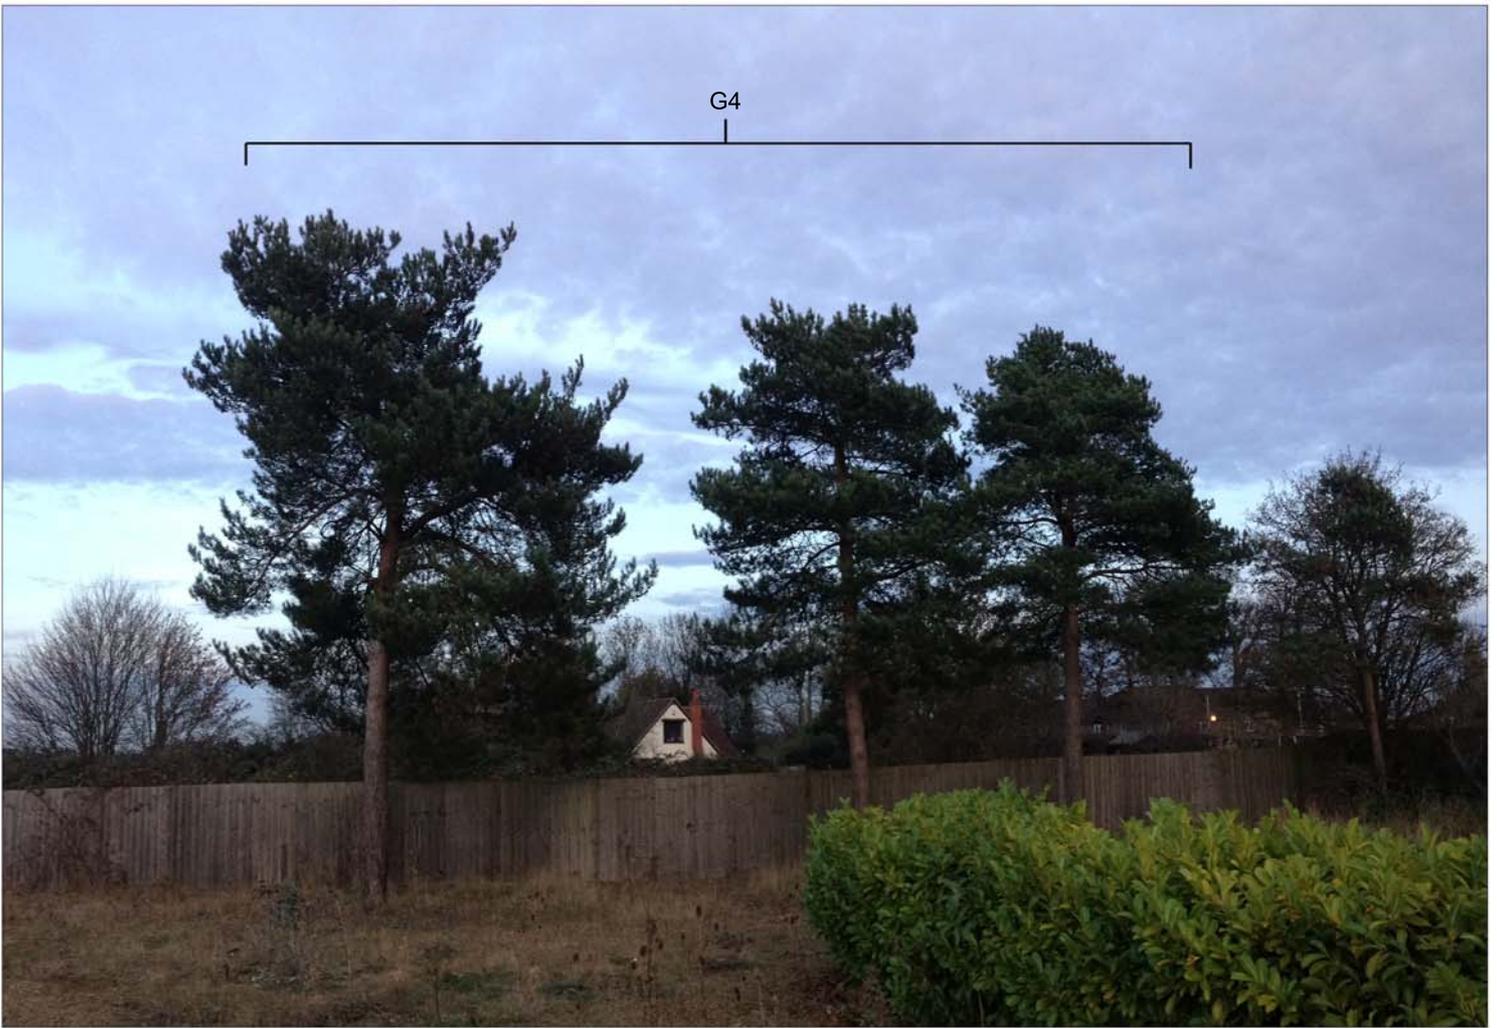
- 3.9. G4, is a parcel of 3no. early mature Scots Pine, positioned within the eastern extent of the existing gravel car park. Although these trees have been exposed to compaction through car park traffic, they are each well established and form a balanced structure which is considered typical for the species. As a collection they represent moderate arboricultural quality and contribute to the internal amenity of the site.

G4 (Scots Pine) - Category B - Located on eastern edge of existing car park

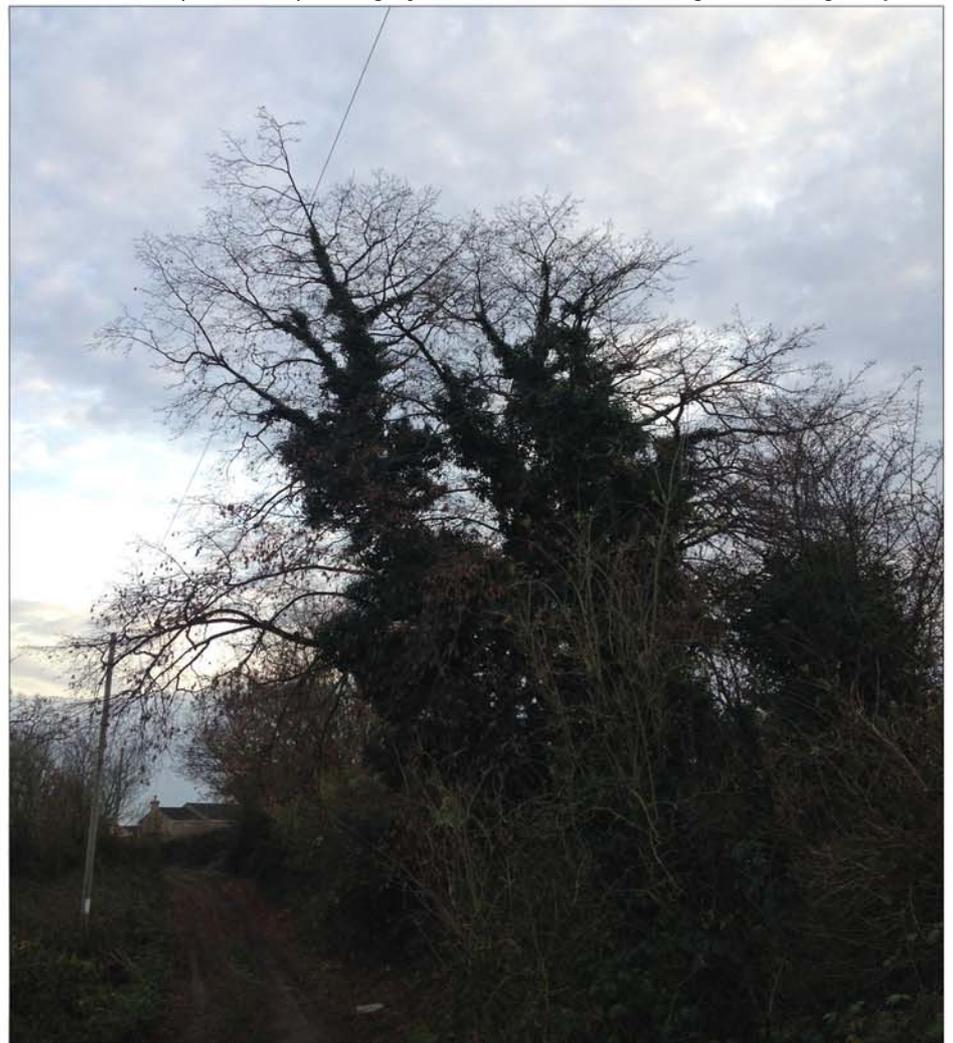
- 3.5. Category A tree cover: T7 Hornbeam, is located offsite on the site's eastern boundary and is considered to be of quality veteran potential. Although the majority of the tree's structure is covered in dense Ivy, which prevented a thorough inspection, the tree appeared to be formed by two boles which have fused together and formed a single feature; measuring 1230mm in diameter at breast height (over Ivy), T7 is considered to be a remarkable size for the species. At circa. 2.5m the tree forks and forms multiple leaders; this union is consistent in appearance with that of a lapsed pollard, suggesting the tree has been exposed to stages of past management. The presence of multiple cavities and pockets of decay within the bole & scaffold structure also contribute to the veteran characteristics of the tree, but in turn have rendered the structural condition to be considered hazardous.

T7 (Hornbeam) - Category A - Located on eastern boundary

- 3.6. On the basis of its veteran features, T7 is considered an aged tree and is afforded special consideration under the NPPF (2012), and should be considered a priority for retention within a future development. However, irrespective of future development, to reduce the risk of failure and to ensure the tree's long-term retention, it is recommended that the duty holder considers entering T7 into a staged regime of retrenchment pruning.
