# **GEO-ENVIRONMENTAL AND GEOTECHNICAL PRELIMINARY RISK ASSESSMENT**

Archer's Spring, Land North of Welwyn Road, Hertford  
London & Regional Properties Ltd.

June 2014

70002900-EF1

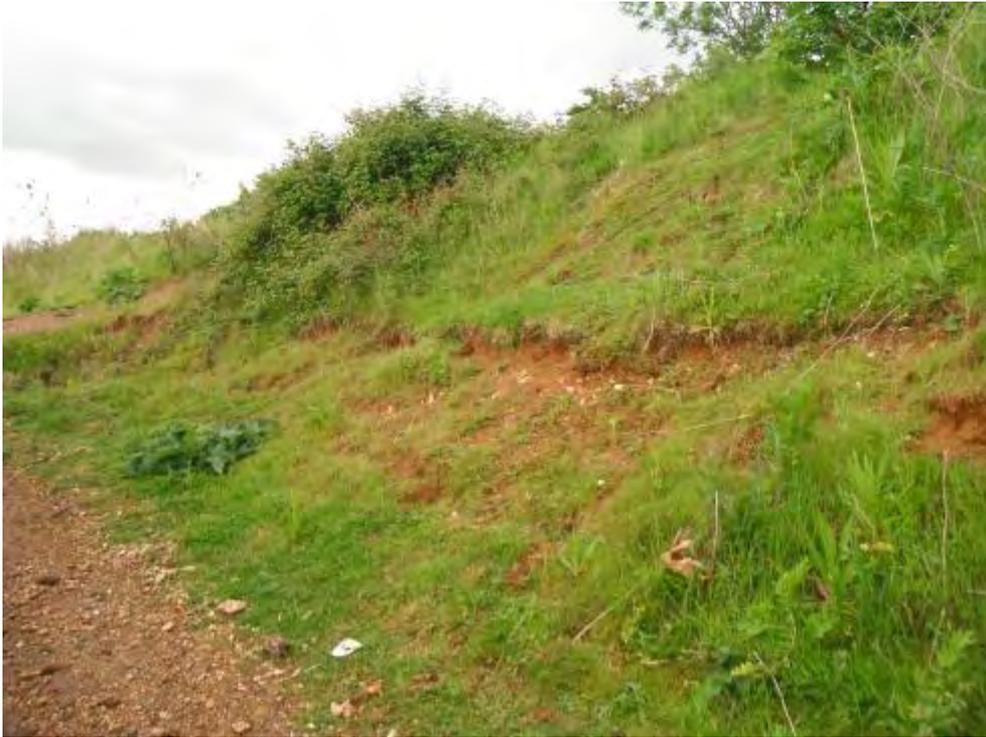
Photo 1: The berm constituting the southern boundary of the site. Photo taken from the base of the ramp connecting the eastern and western plateaus.

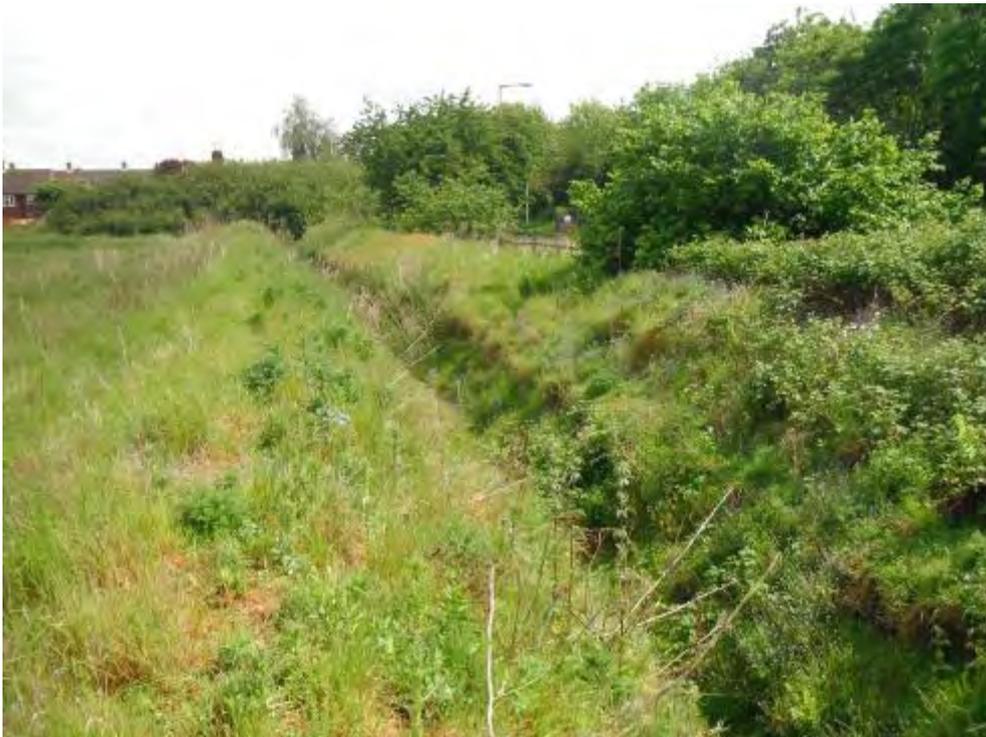
Photo 2: The dry ditch within the berm, situated in the south east corner of the site. Photo taken from the top of the berm at the end of the dry ditch.

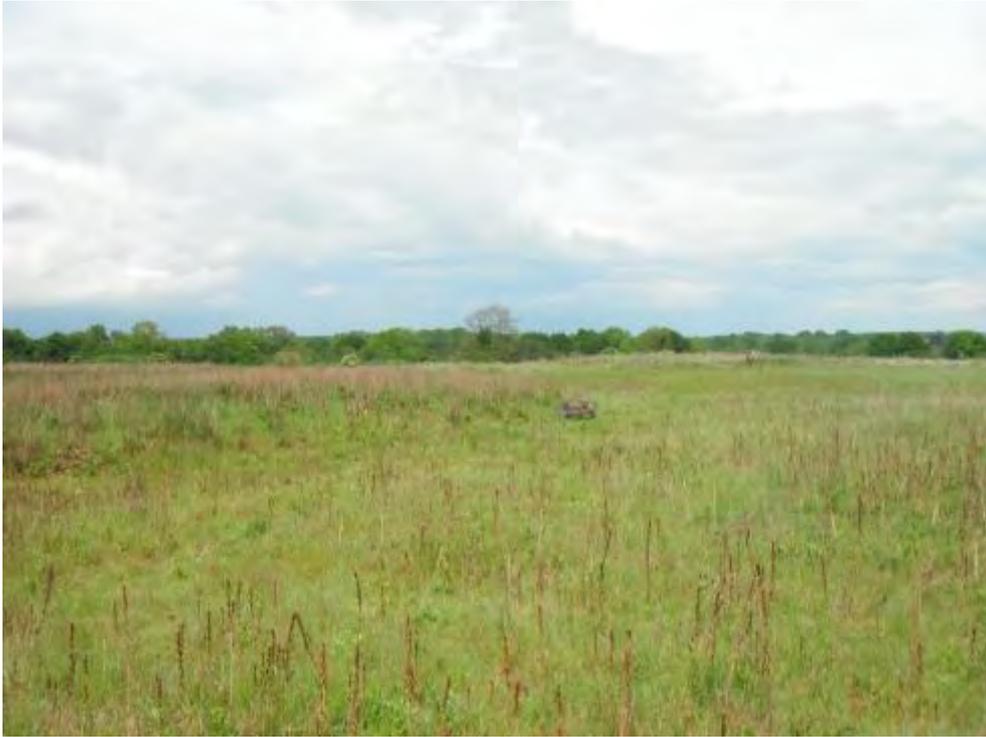
Photo 3: An overview of the eastern plateau. Picture taken from the top of the berm.

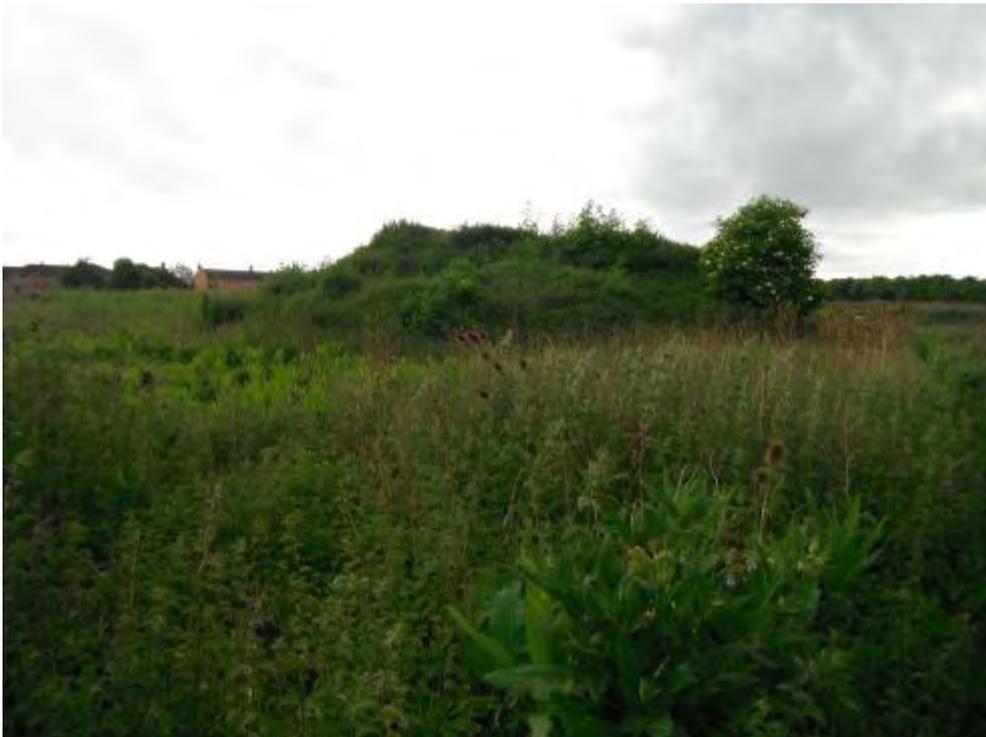
Photo 4: A large 3-4m tall earth mound, situated on the eastern plateau. Photo taken facing south in the northern section of the eastern plateau.

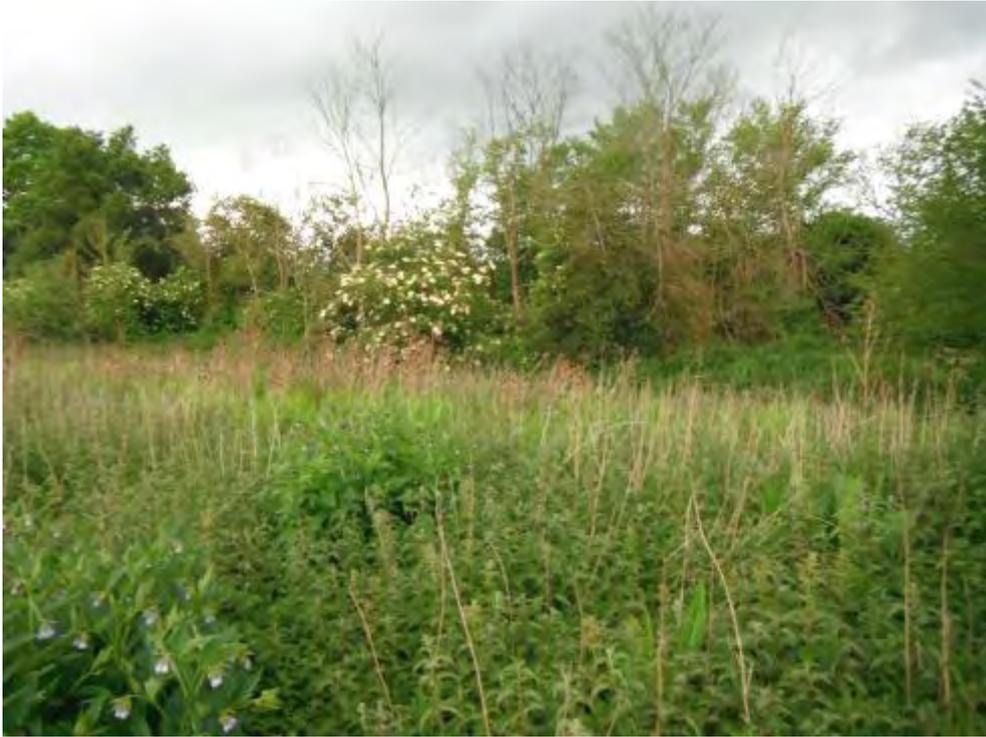
Photo 5: The wooden spur, as seen from the eastern plateau. Photo taken adjacent to the large earth mound, facing east.

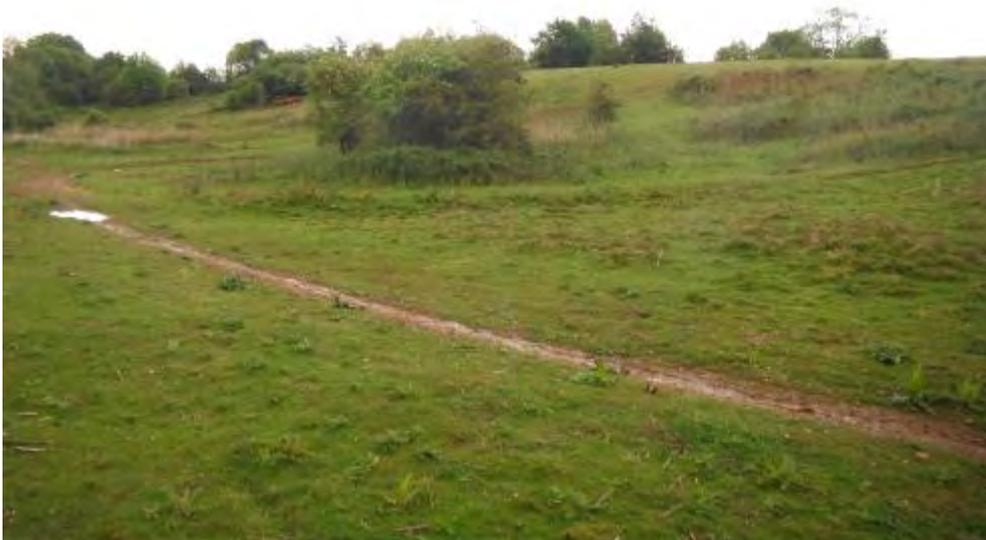
Photo 6: An overview of the western plateau, facing north, towards the local wildlife site.

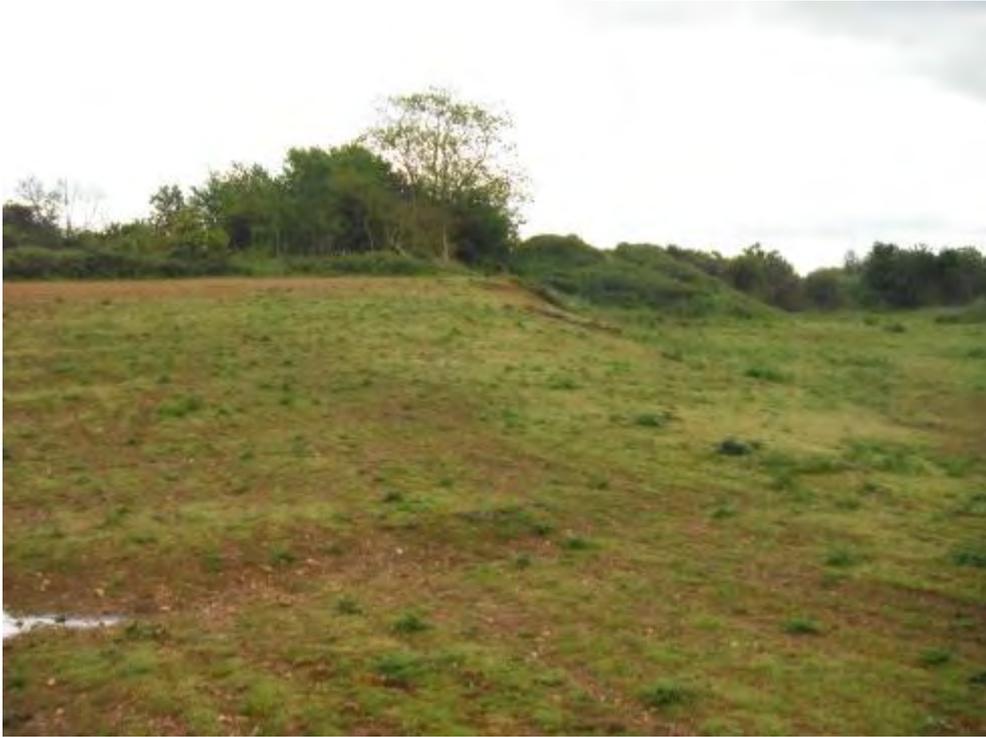
Photo 7: An overview of the eastern plateau, facing north east. The wooded spur is visible in the centre of the photo. Photo taken from the centre of the eastern plateau.

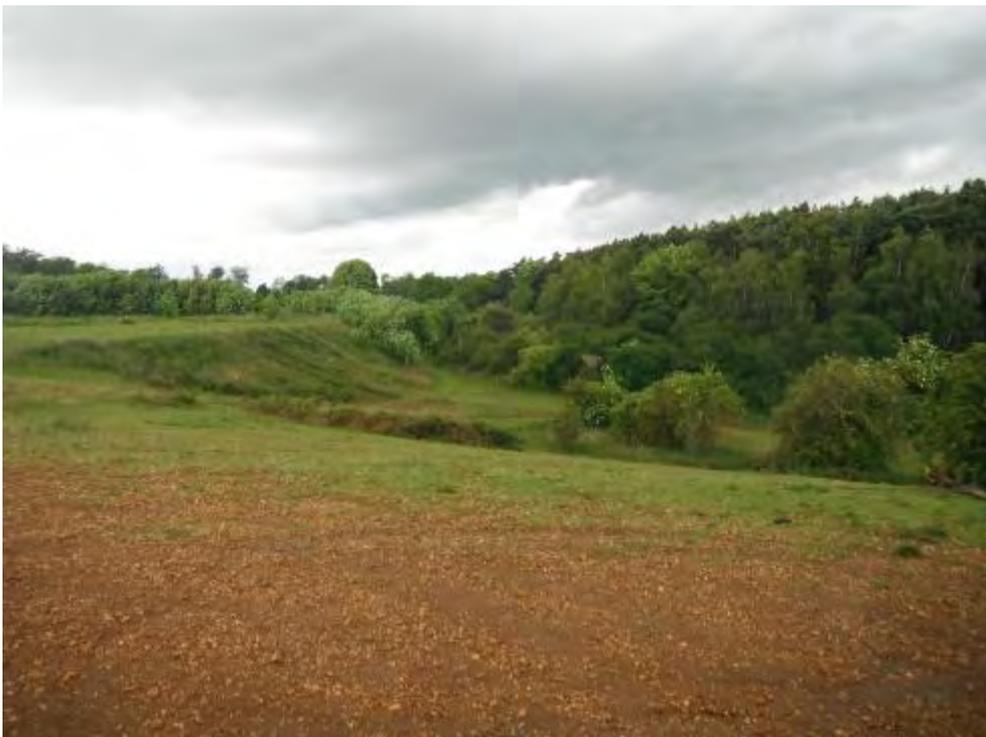
Photo 8: An overview of the local wildlife site with local gravel paths. Photo taken from the southern end of the wooded spur.

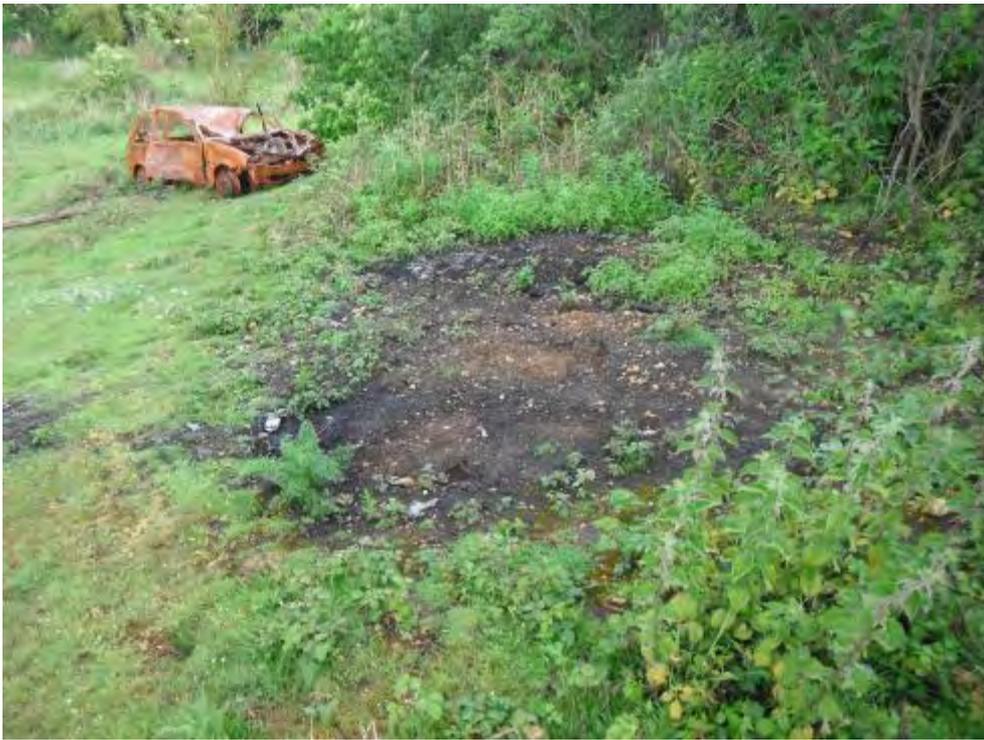
Photo 9: The rusted car and localised area of burning. Photo taken within the local wildlife site.

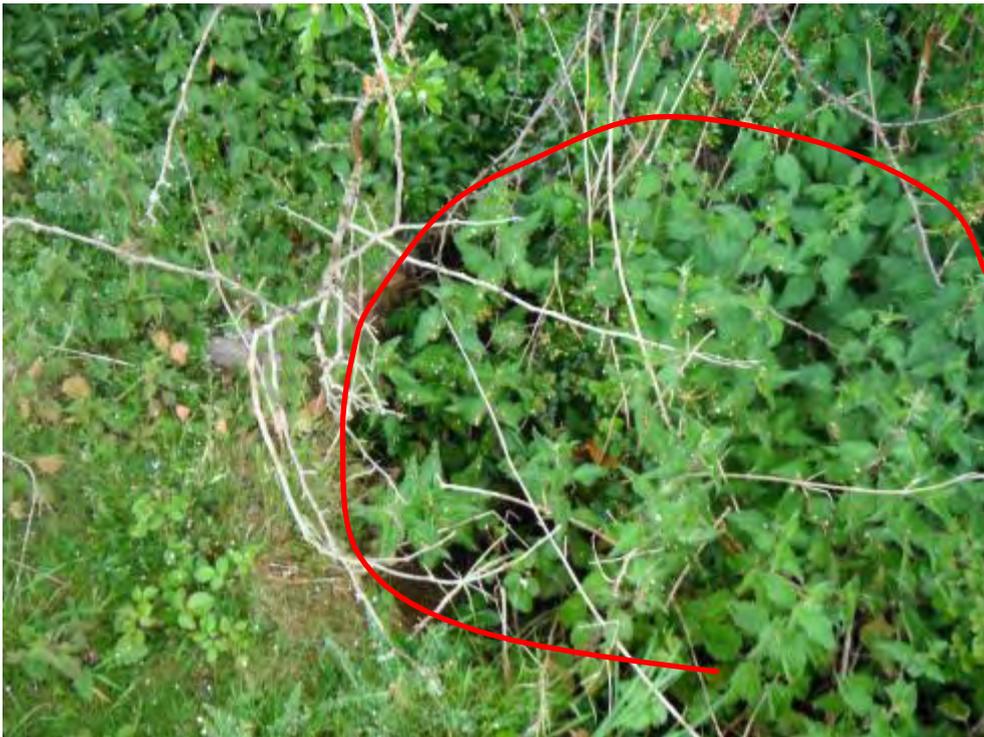
Photo 10: A potentially small solution hole noted in the woodland adjacent to the north of the site. Photo taken on the northern boundary of the site, adjacent to the local wildlife site. Approximate extent of solution hole marked by red line. The diameter is approximately 1m to 2m.

- It is recommended that a factual report and risk assessment using the national cavity database, as held by Peter Brett Associates, regarding natural and man-made cavities in the vicinity of the site is obtained, due to the potential presence of chalk solution features.

- It is recommended that due to the presence of the chalk and the need to identify any potential solution features, a Ground Investigation is undertaken. This would assist in the characterisation of the site, further delineate the lateral extent of the Made Ground, supplement existing contamination data and inform foundation design.
