**TIER I DESKTOP STUDY REPORT**  
**Weston Homes Plc**  
**Bishops Stortford Golf Club, Dunmow Road, Bishops Stortford,**  
**Hertfordshire**

CON1-BISH-023 – Bishops Stortford Golf Club; Tier I Desktop Study

**Publication Title** Tier I Desktop Study Report  
Bishops Stortford Golf Club, Bishops Stortford

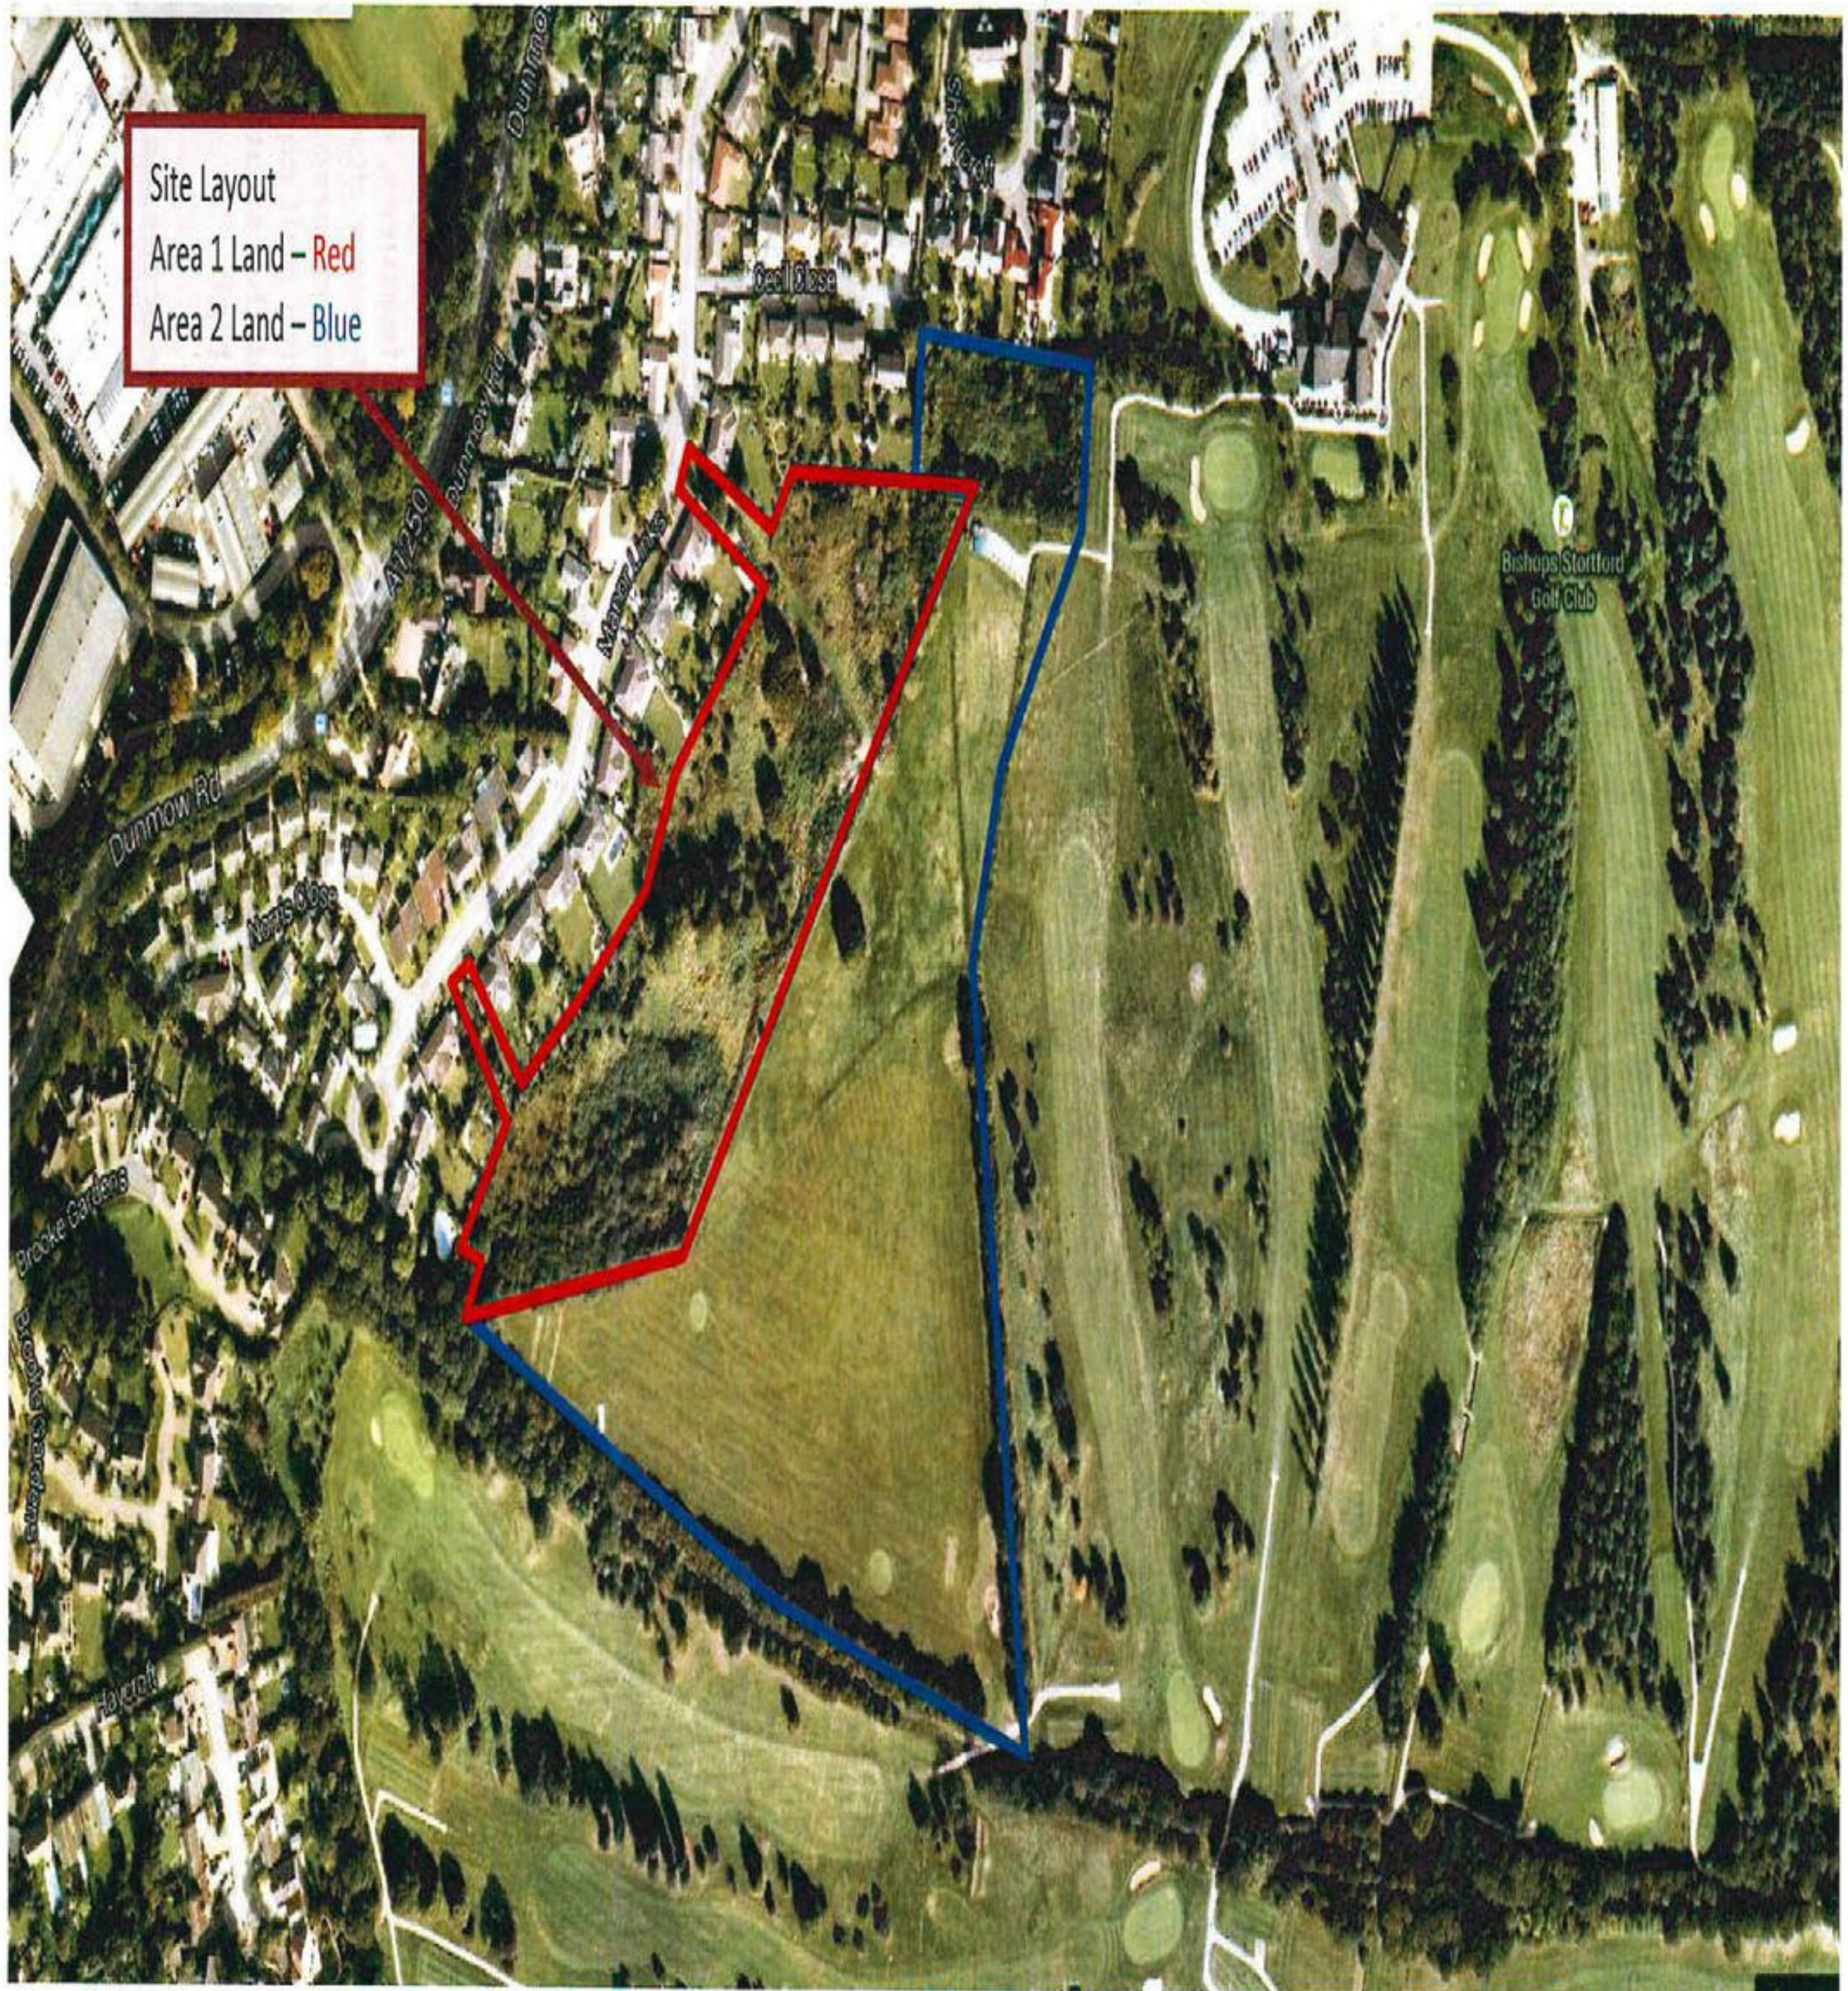
Figure 2 - Current Site Layout

The site was roughly triangular in shape, covered an area of approximately 5Ha and was split into two development areas (see figure 2 below). The Area 1 land was closest the western boundary of the golf course and comprised rough, scrubby, heavily vegetated, unkept land. Within it was evidence of bonfires, presumably from vegetation clearance. Furthermore some small excavations, with resultant spoil heaps were also present within this area, although it was not obvious as to their purpose (possible uses could be former golf course features, e.g. bunkers, or to aid site drainage - they contained standing water). The soils exposed were disclosed as gravelly sandy clays. The Area 2 land was set to grass and was partly used as the course's driving range. A wooded area was also present in the northern part of Area 2, along with golf course drains noted in the southern part. A vegetated former railway embankment formed the southern boundary of the study area, mostly beside Area 2, and was approximately 3 metres high.

The site is accessed via the main golf course car park, but two vehicular accesses exist from Manor Links. The current site layout is shown in Figure 2.

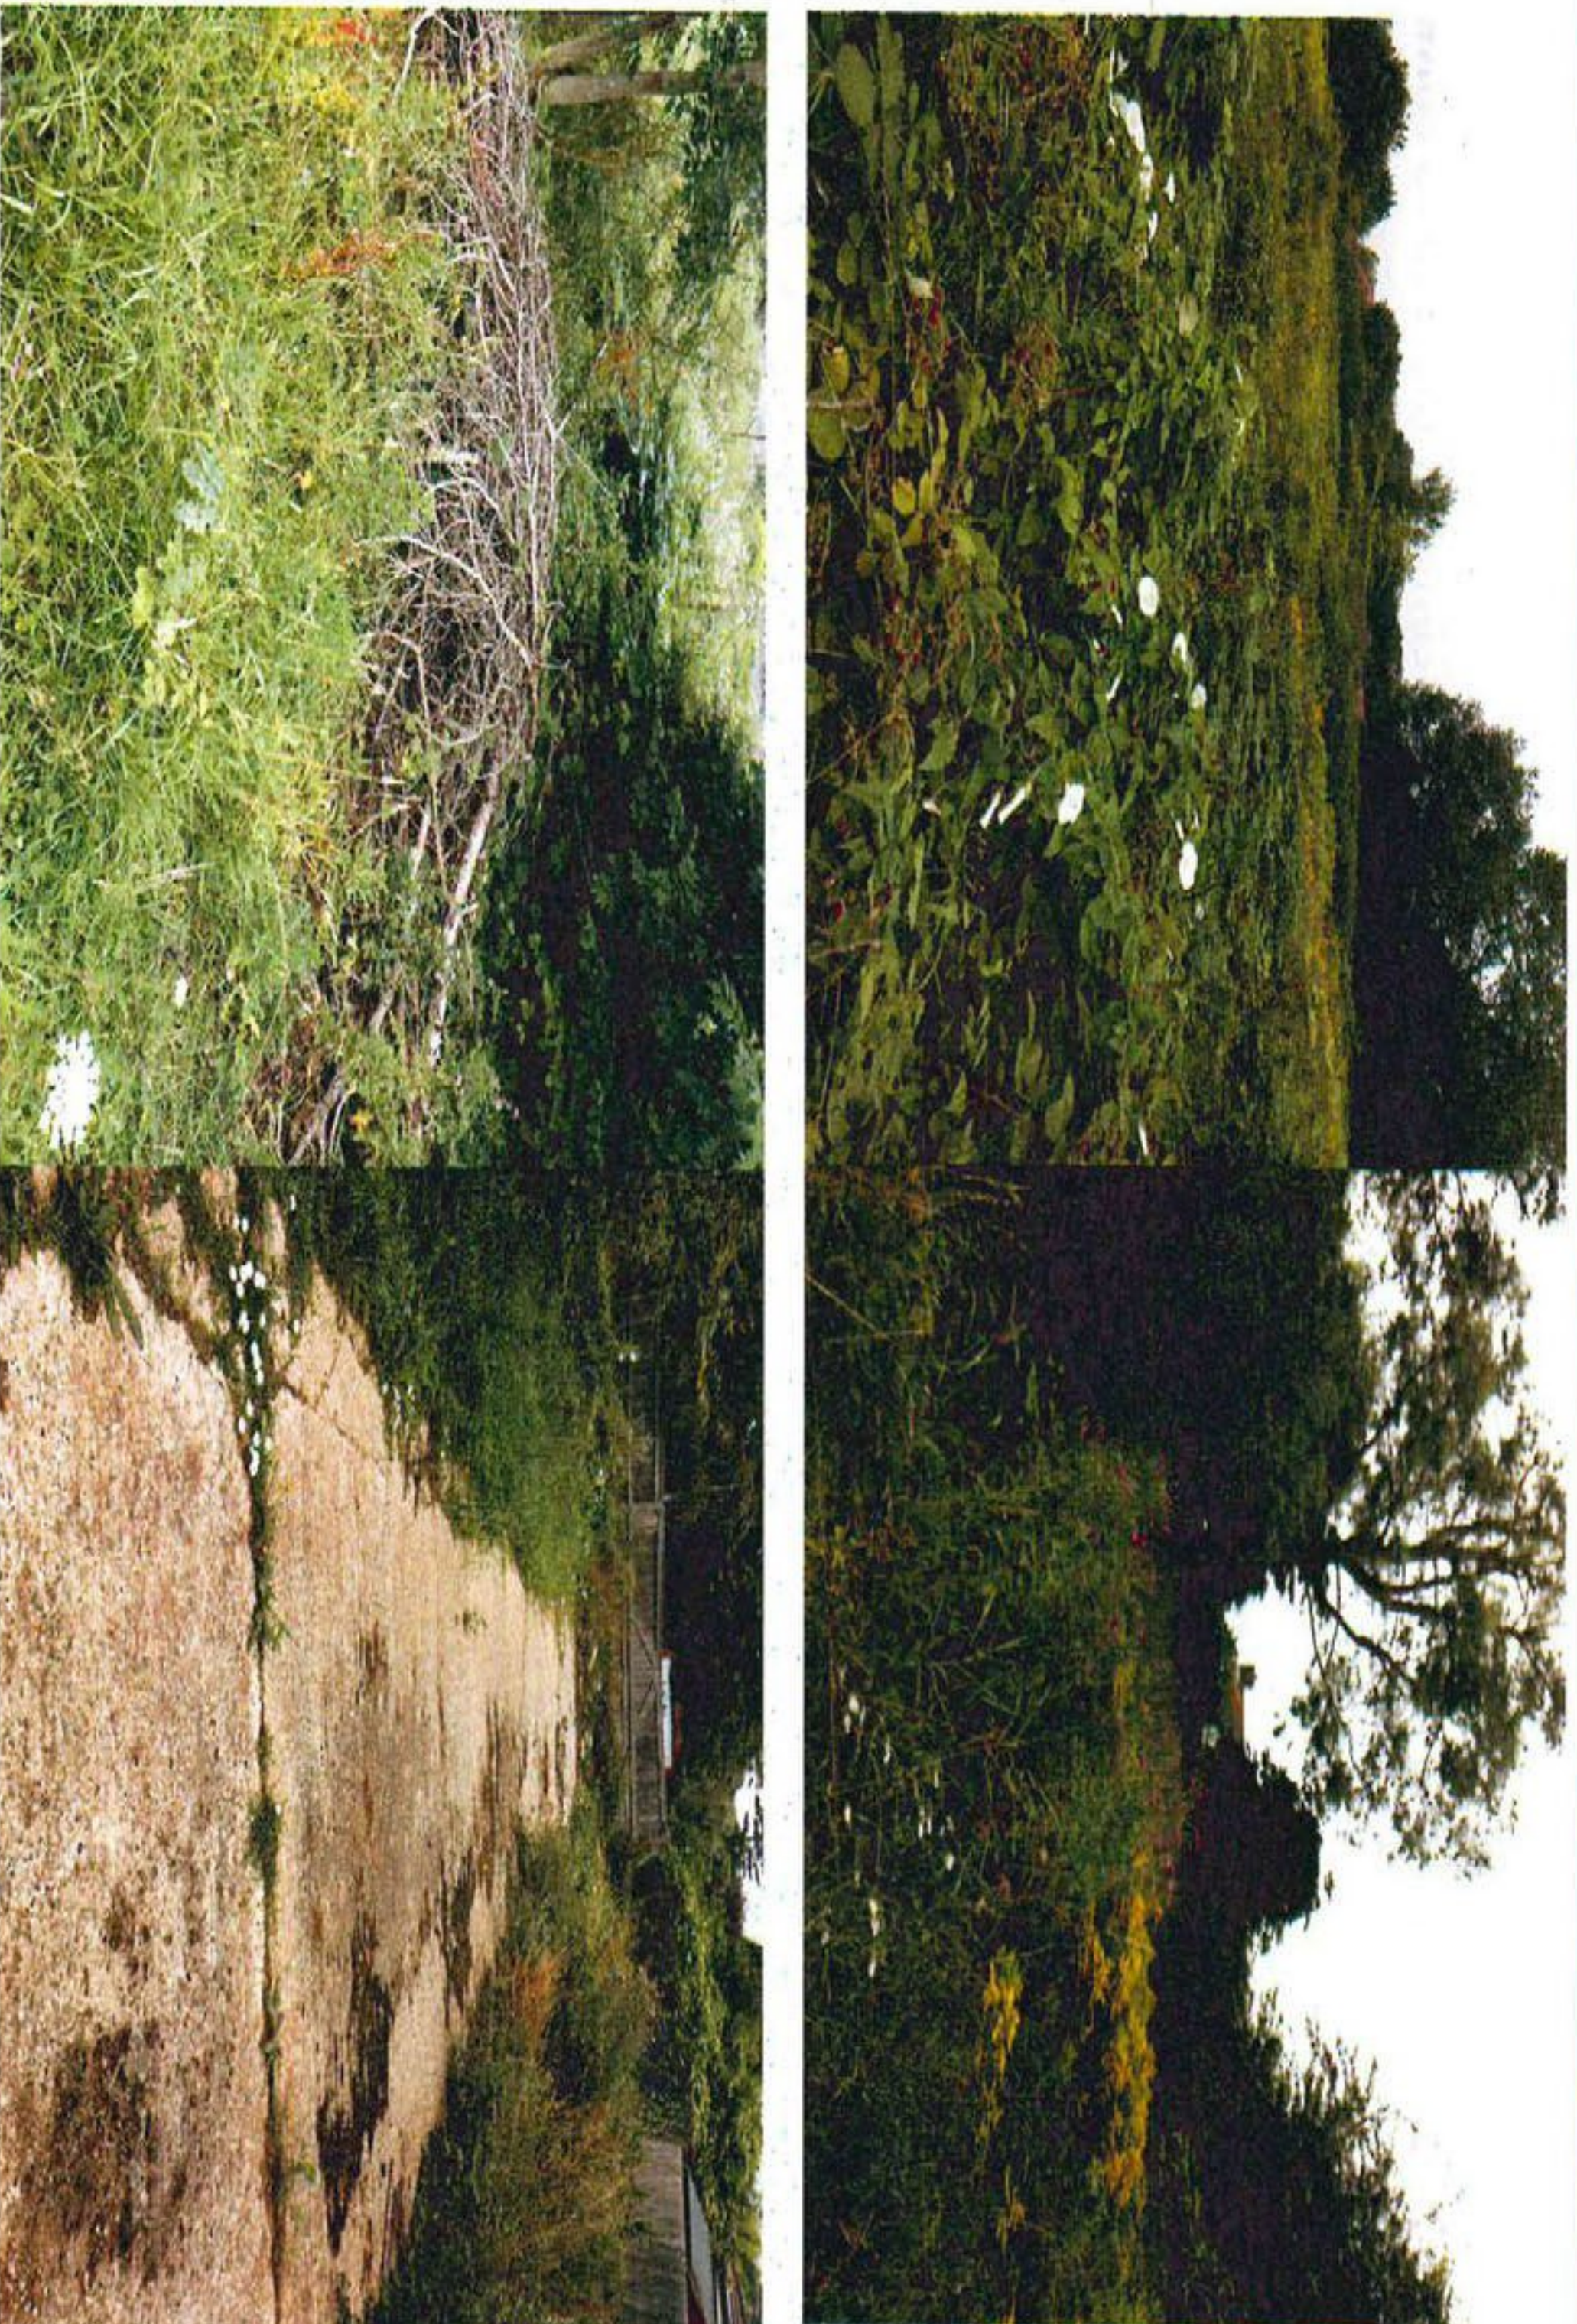
The land was currently part of the Bishops Stortford Golf Course. The Area 1 land was largely unkept and overgrown, whilst the Area 2 land was maintained grass.

The photographs above show general views of the Area 1 land including one of the accesses from Manor Links

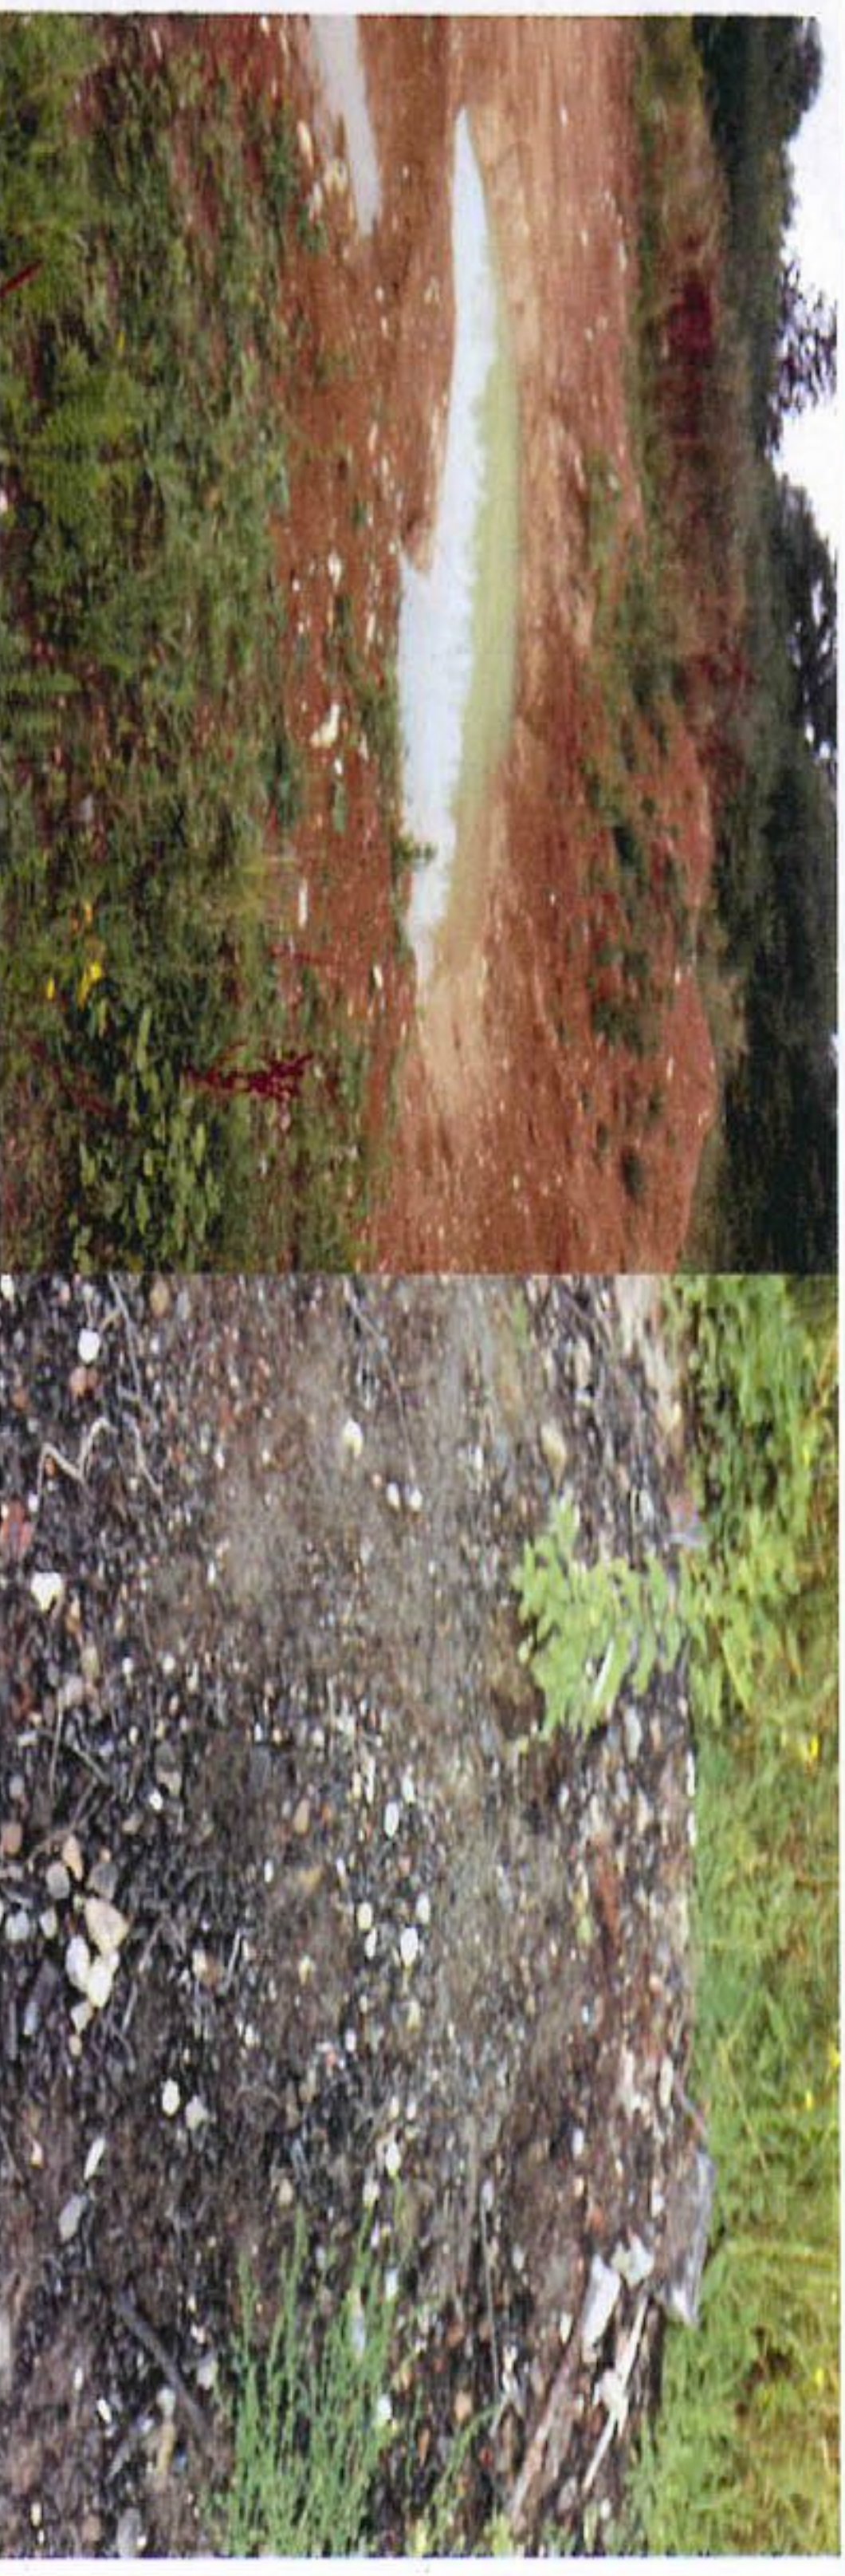
The above photographs show the shallow excavations and the evidence of bonfires.

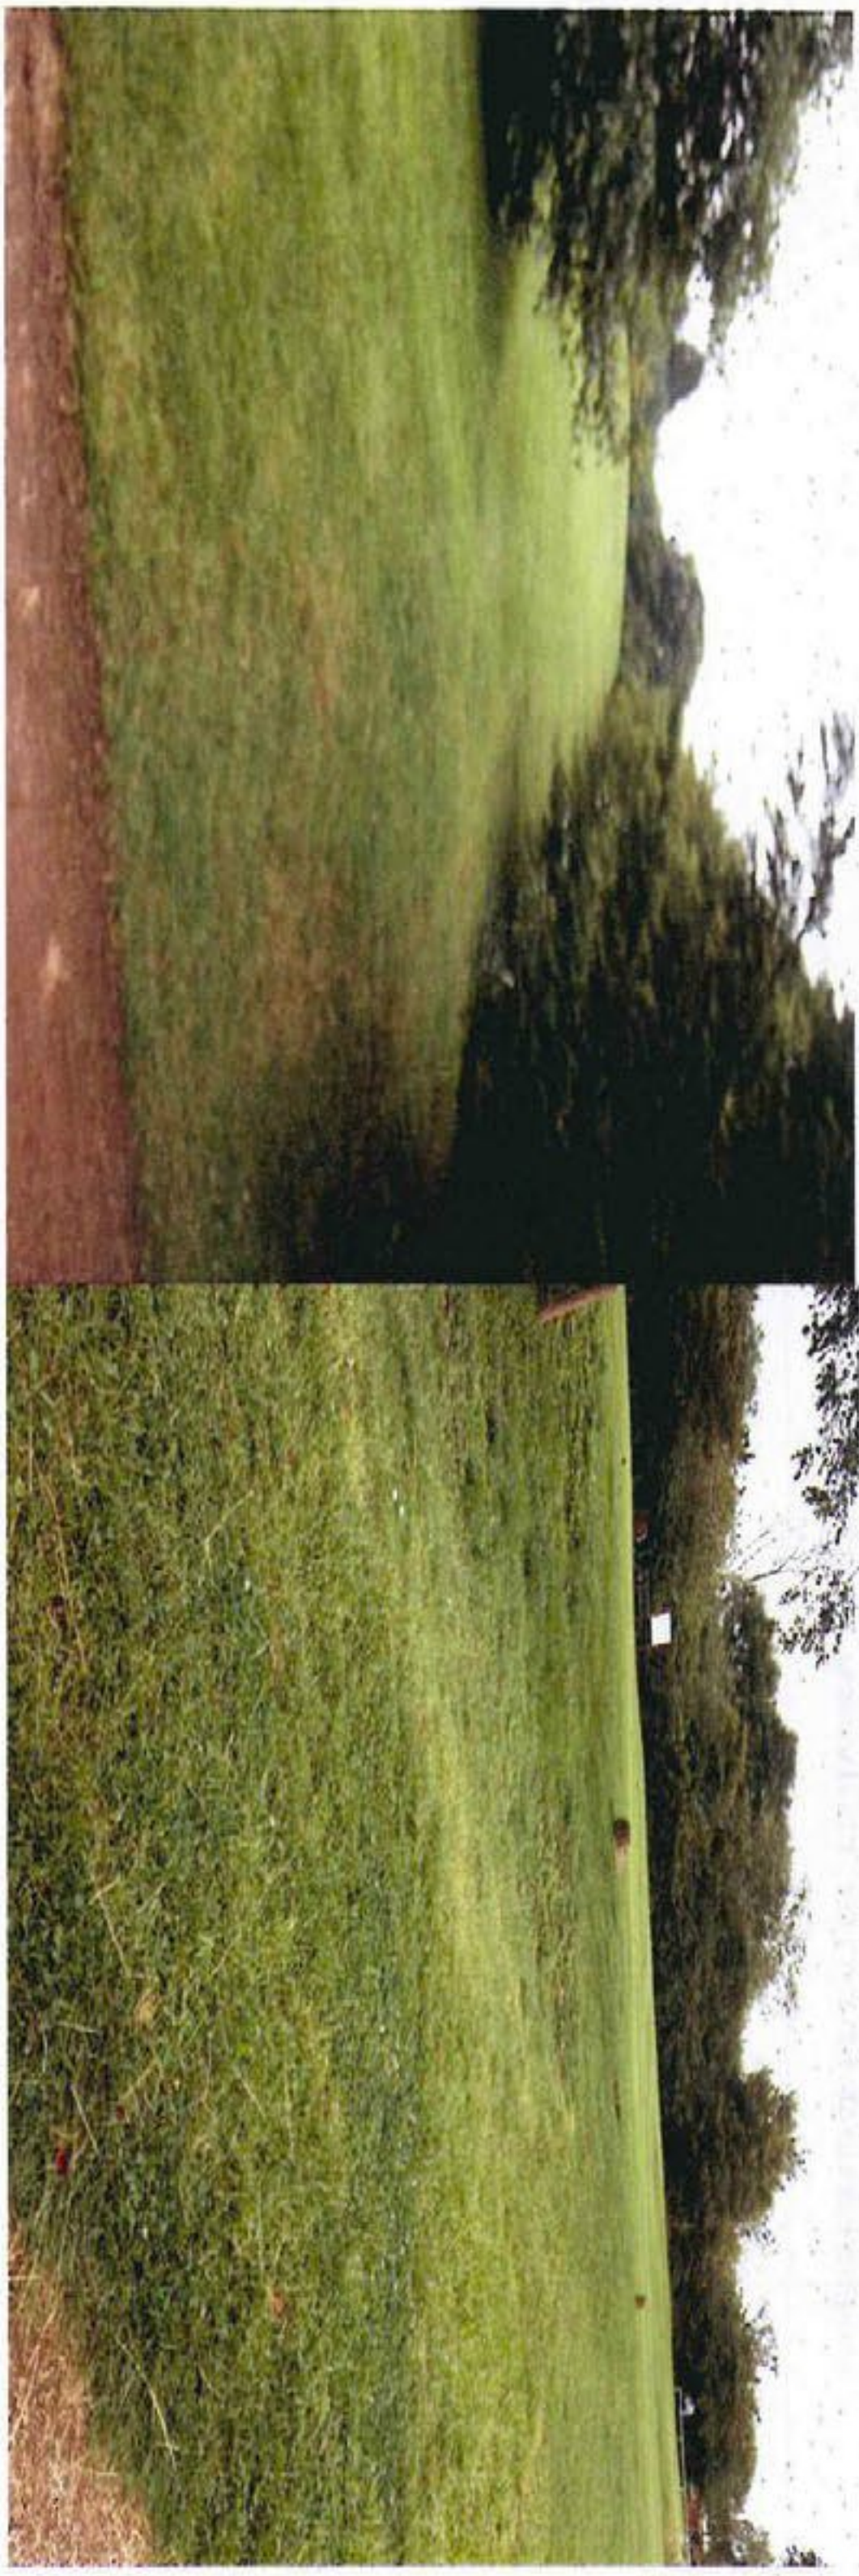
The above photographs show general shots of the Area 2 land.

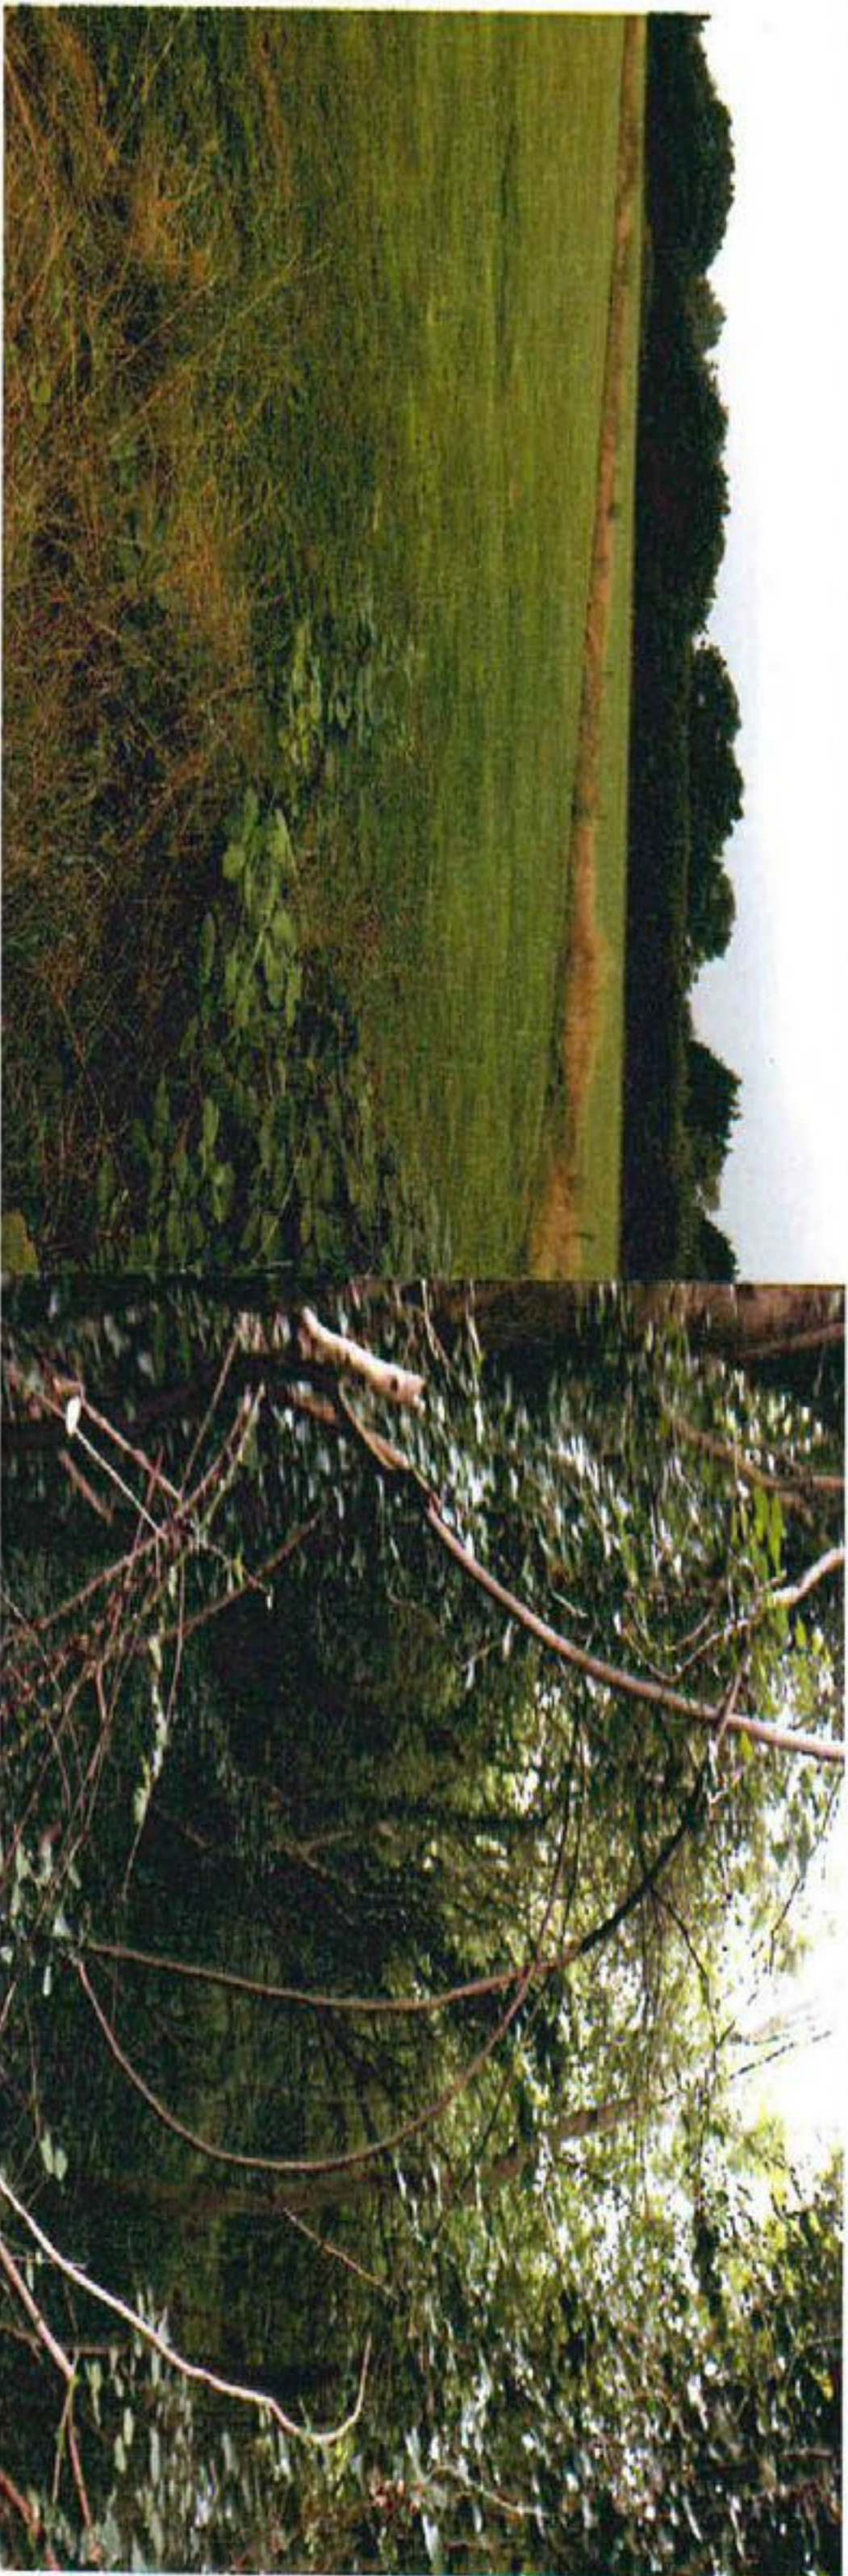
**The above photographs show the golf course drains crossing the study area and the heavily vegetated former railway embankment.**

- The presence of the former railway embankment and the potential for the spread of ash, clinker and coal within its make up and during its operational use
