Arboricultural Note

Project: Bengo Nursery (ARB9392)

Preliminary Arboricultural Appraisal

December 2016

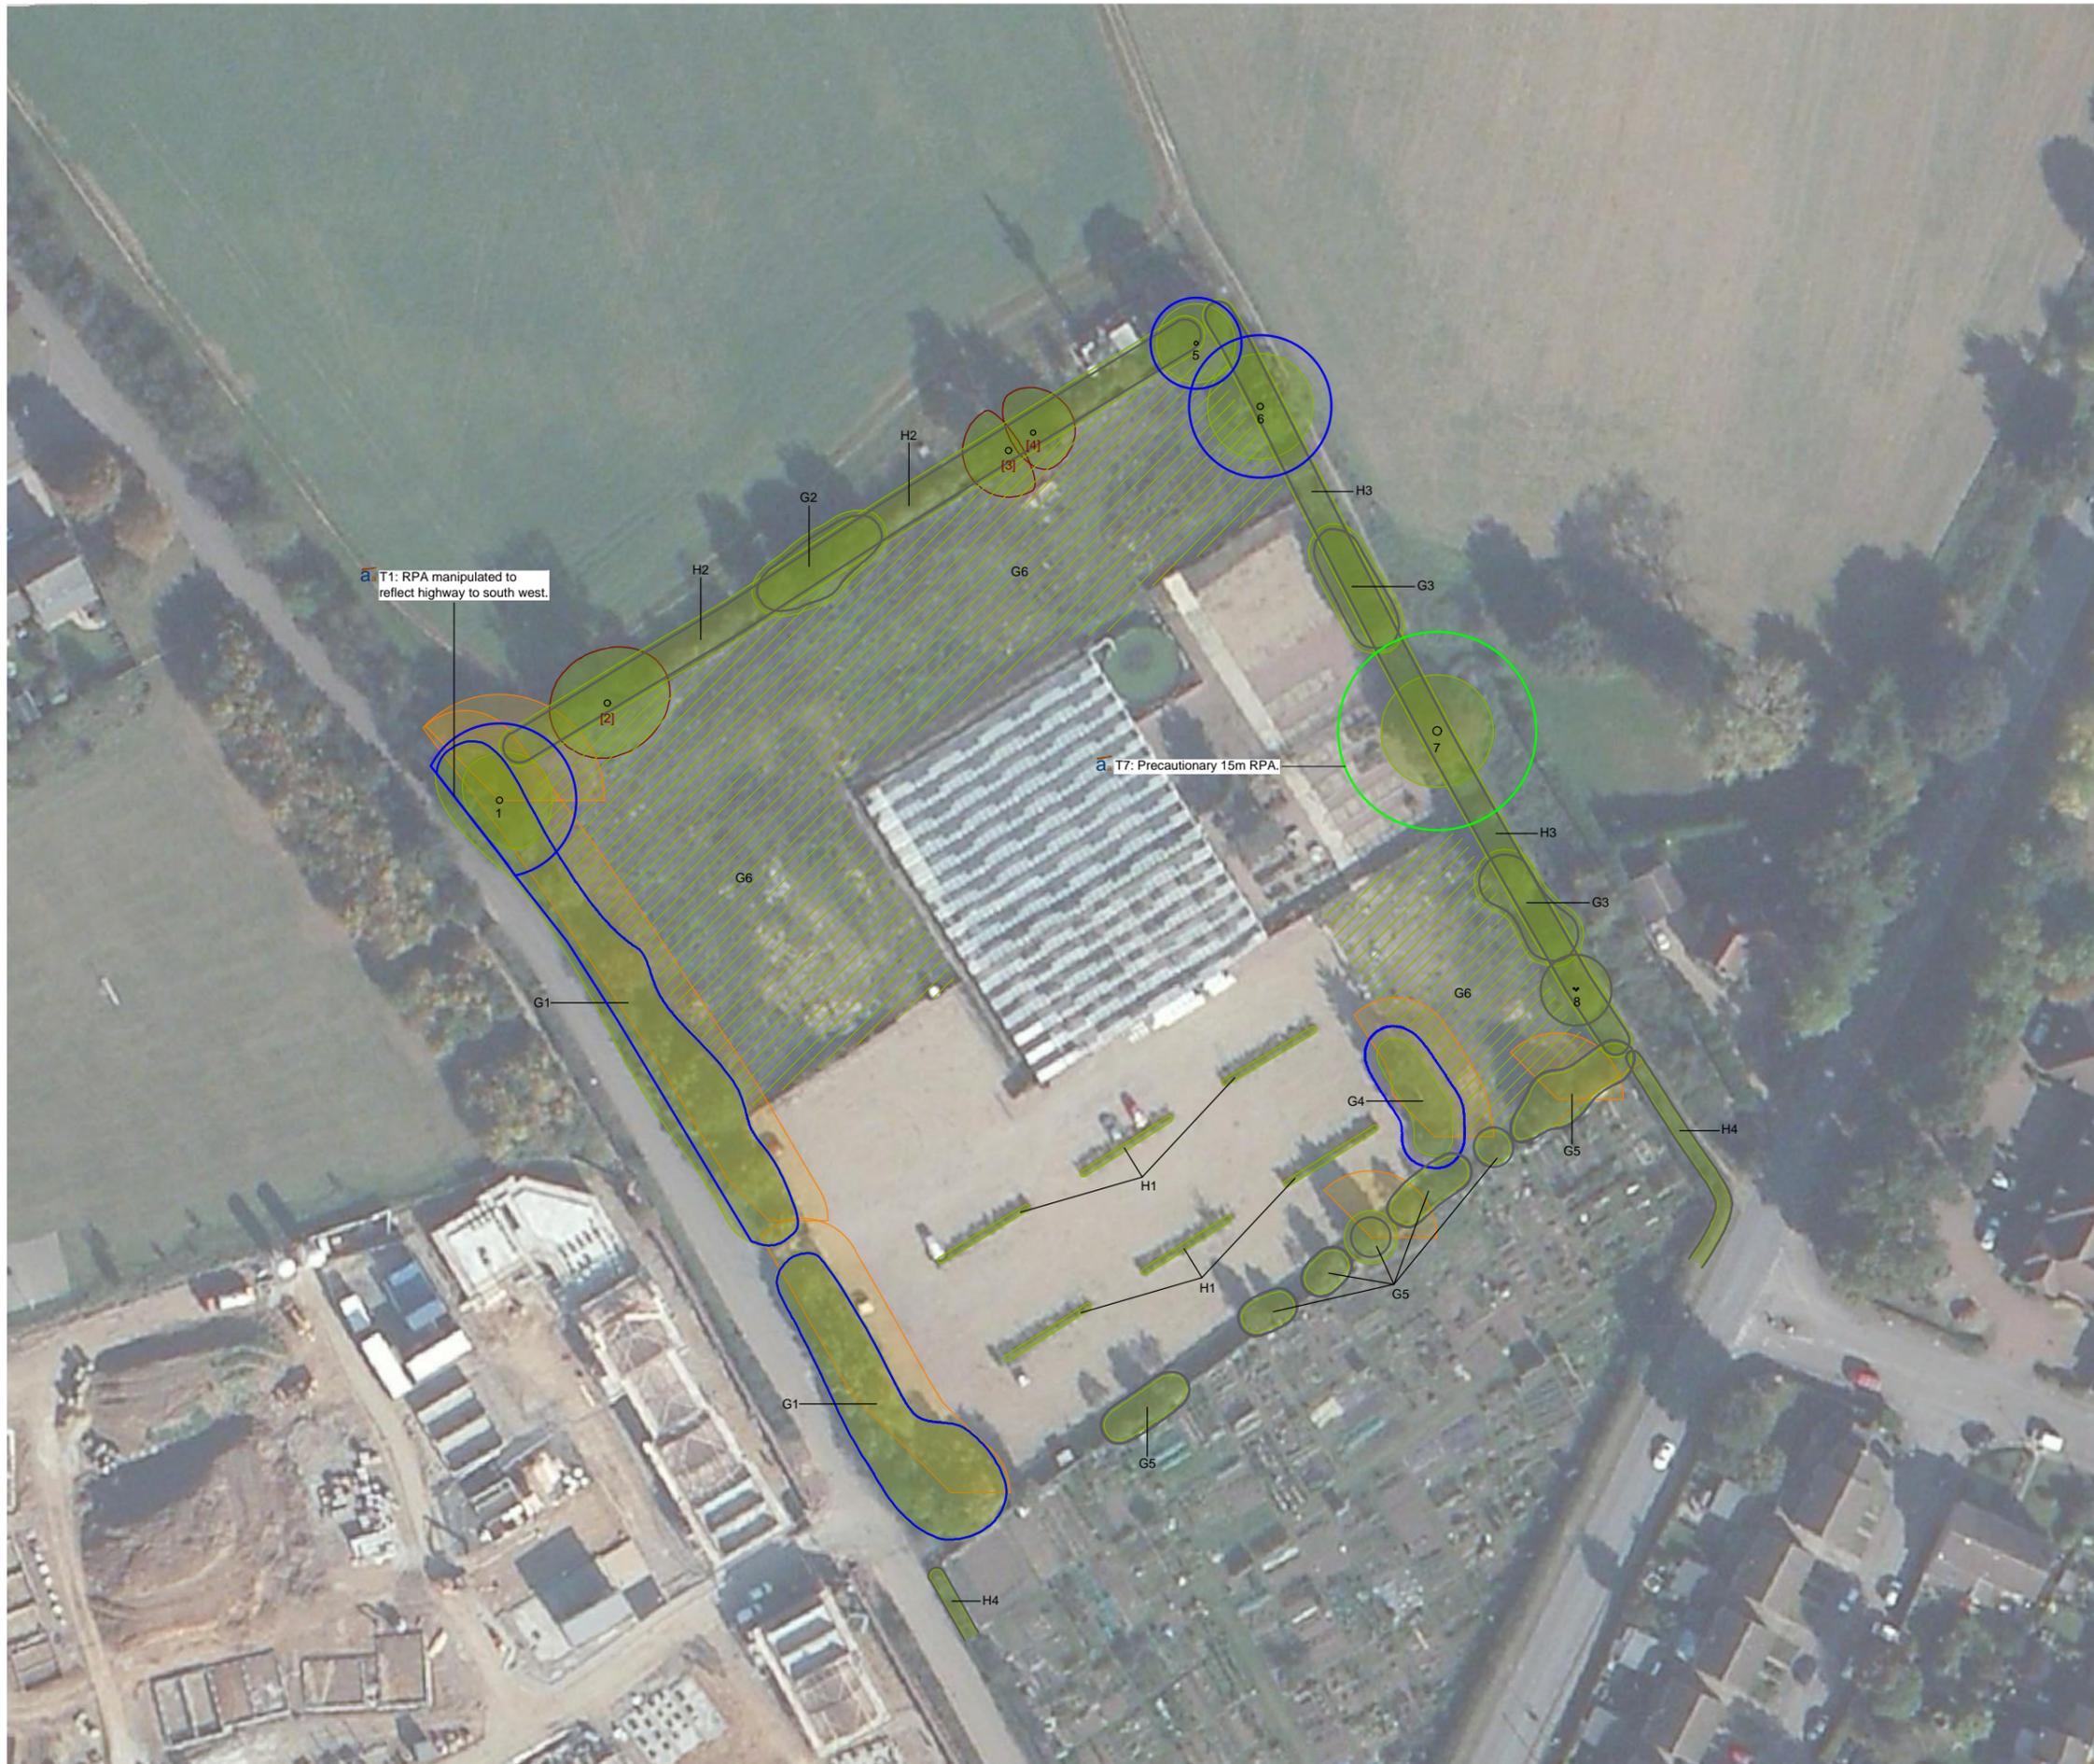
Enclosure B: Preliminary Tree Constraints Plan (9392 TCP 01)

- 3.10. Category U tree cover: Three offsite trees positioned on the site's northern boundary are considered unsuitable for retention regardless of promoting the site for development. T2 Ash and T3 Sycamore, both feature a significant amount of decay within large basal cavities. As such, their early loss is anticipated through structural failure. T4 Lime, has significant dieback within the upper canopy and is considered to be in a state of terminal decline.
